GREEN INFRASTRUCTURE PILOT PROJECT - CONDADO LAGOON ESTUARINE RESERVE FINAL REPORT

I. Green Infrastructure Assessment at Condado Lagoon

A. SUMMARY OF EXISTING CONDITIONS, FINDINGS & RECOMMENDATIONS

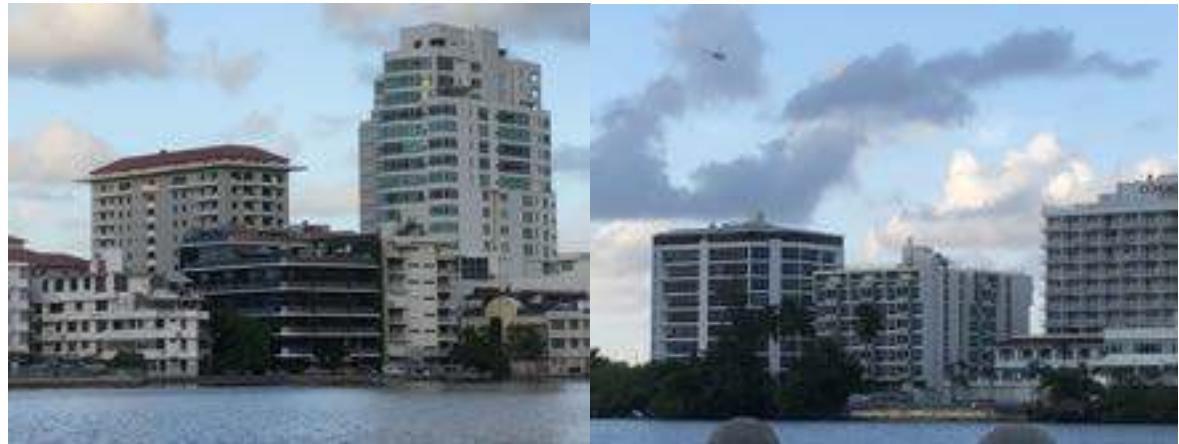
To the north, areas of the Lagoon where patches of vegetation are missing can be attributed to streets or recent/new construction along the water's edge. Those spots appear to coincide with area resident's complaints about presence of oil or greasy substances at the edge, as well as others. In addition, areas where the presence of red mangroves is also missing is attributed to wave energy which moves the new seedlings hampering their establishment along with constant removal of a planting substrate.

Figure 3. Street edge and new construction at the water's edge. (photo courtesy M. Rodriguez)

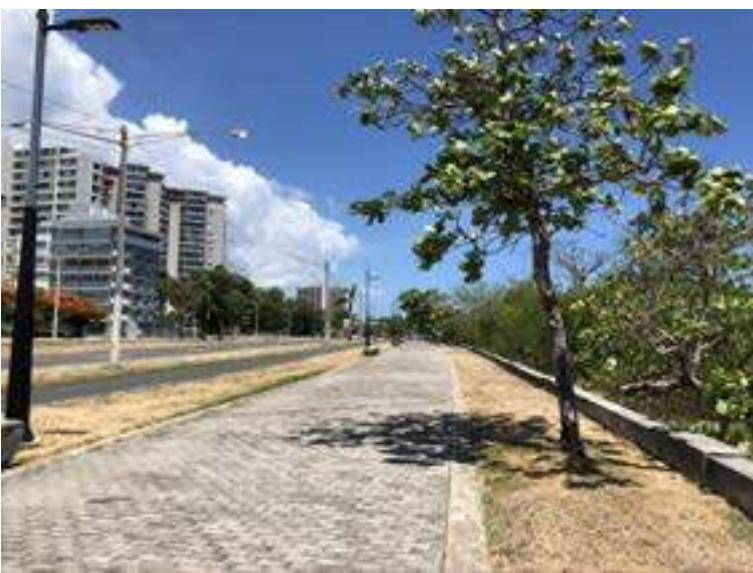
The boardwalk is lined with *Terminalia catappa*, a number of which were possibly lost as a result of hurricanes Irma and Maria. Even though this is a non-native species, it is locally naturalized and could provide much needed shade along the boardwalk area. Additionally, it would serve to consolidate the existing tree line along the south border of the boardwalk.

Figure 4. Line of Terminalias missing several specimens to be replanted for shade. (Photo courtesy of M. Rodriguez)

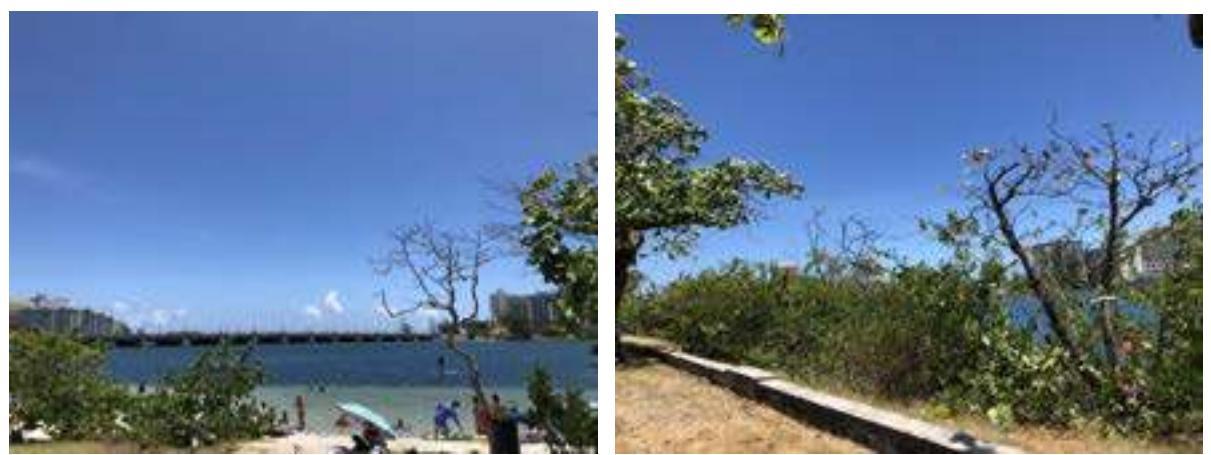
Several existing trees are dead but still standing in the area. These should removed or converted to mulch for area use as they constitute a risk to the safety of area users and/or property. As trees and branches decay and other organic detritus is collected at the site, these could be chipped by Park personnel in order to reuse as mulch on site or to be sold to the public.

Figure 5. Examples of dead trees to be considered for removal and converted to mulch. (Courtesy of M. Rodríguez)

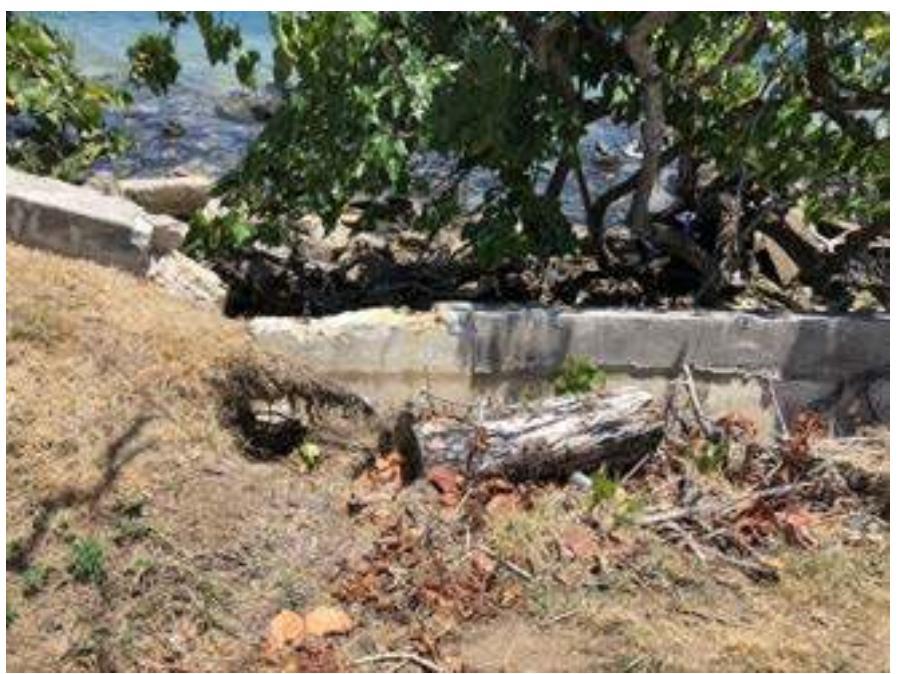
The southern side of the Condado Lagoon presents areas of significant erosion, a partially collapsed concrete retaining wall and collapsed grassed areas. These constitute a risk to the safety of area users and need to be addressed immediately by the corresponding partner agency as a precautionary measure.

Figure 6. Eroded embankment area and partial retaining wall collapse. (Courtesy of M. Rodríguez)

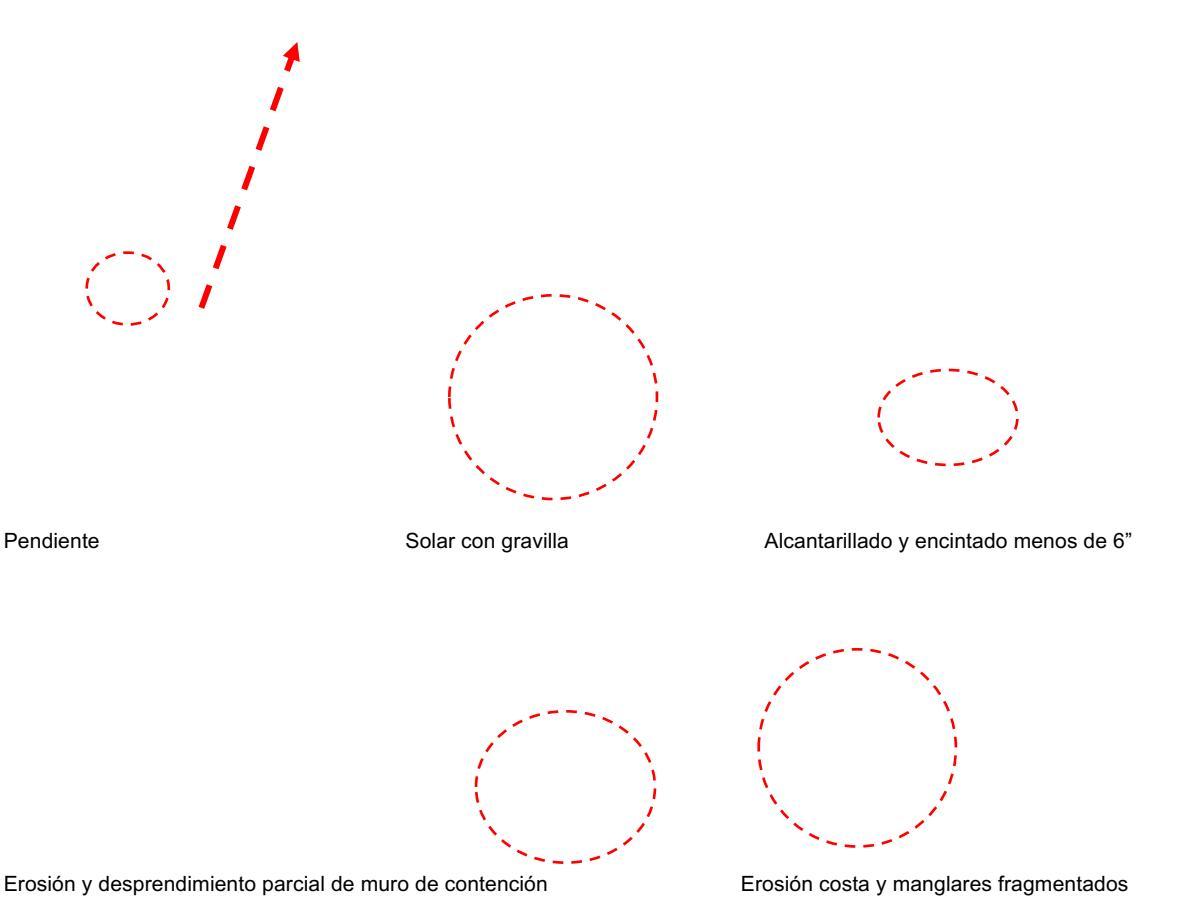
Following several visits to the site and observing the flow of water, it is considered highly probable that storm runoff stemming from streets located on higher ground to the south of the Lagoon, are contributing to the erosion found at critical points in the boardwalk. These highly eroded points appear to coincide with the topographic condition, runoff velocities, and the location of stormwater infrastructure. In several points along Baldorioty Avenue it was also noted that the height between the curb and the infrastructure grill did not exceed 3" as opposed to the regulatory 6", which may be causing water to flow more slowly thus accumulating sediment along these areas.

Figure 8. Relationship with topographic changes on the southernmost side of Baldorioty Avenue. (Courtesy of M. Rodríguez)

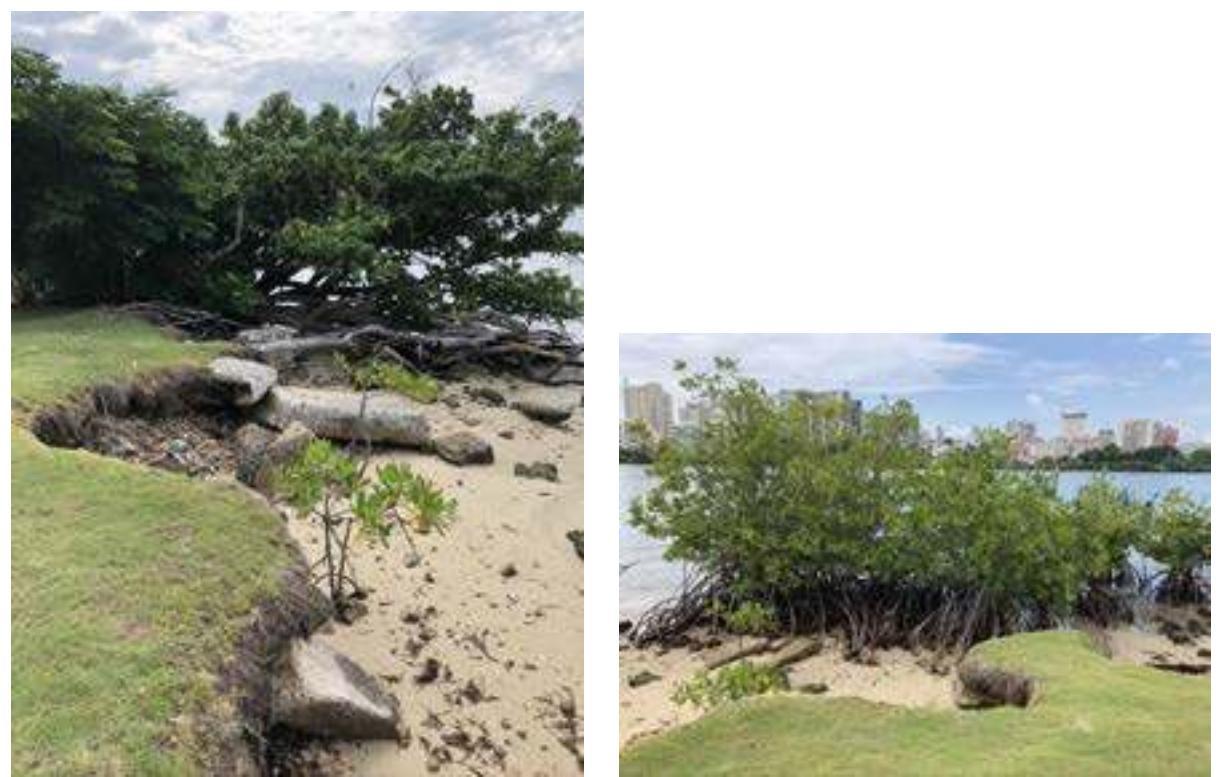
At the northern side of the Lagoon it appears that erosion is being caused partly due to the energy of waves entering the lagoon on the northeastern edge, removing sand particles and depositing them on the southwestern side, the small beach area. Erosion heights differ anywhere from approximately 5'-0" to 6" depending on the area along the edge, the waves' energy, the level of erosion and the use by visitors. Therefore, reforestation on this side of the lagoon may need to consider various planting techniques which address embankment stabilization concomitantly.

Figure 9. Eroded beach edge on the north side with discrete red mangrove plantings. (Photo courtesy of M. Rodriguez)

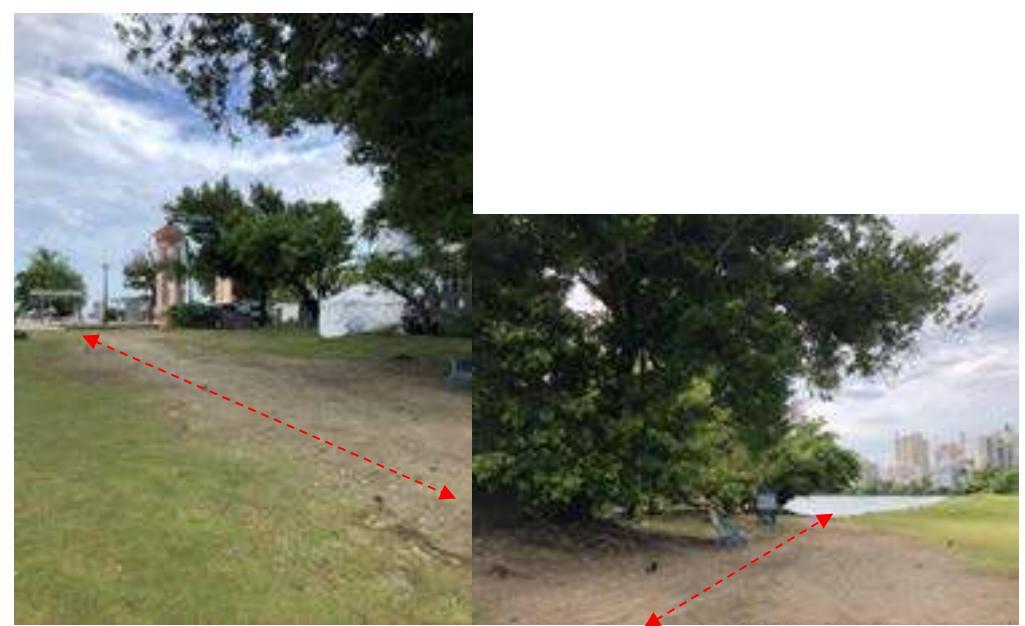
The area to the north of the Condado Lagoon runs a concessionary business operation of aquatic equipment. The concessionary has established movable structures and framework as storage for kayaks, paddle boards, among others along the built perimeter of the area buildings up to an enclosure with cyclone fencing. Pedestrian traffic over this grassed area has compacted the soil and eroded the most heavily trafficked sector. Redesigning the area to consider circulation and equipment storage should be reconsidered in order to mitigate the impact over this area.

Figure 10. Compacted and eroded soils due to pedestrian traffic. (Photo courtesy of M. Rodriguez)

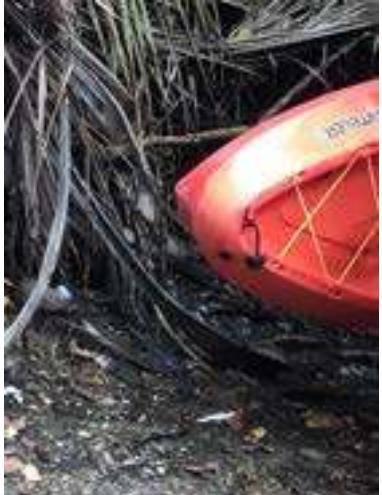
During one of the visits a discharge point was observed stemming from one of the existing buildings. The event lasted briefly. The previous night the sector experienced a heavy downpour which, as explained by the Project Manager De la Cruz, may explain that the building might have been pumping rainwater out of a basement.

Figure 12. Direct discharge into Lagoon's water. (Photo courtesy of M. Rodriguez)

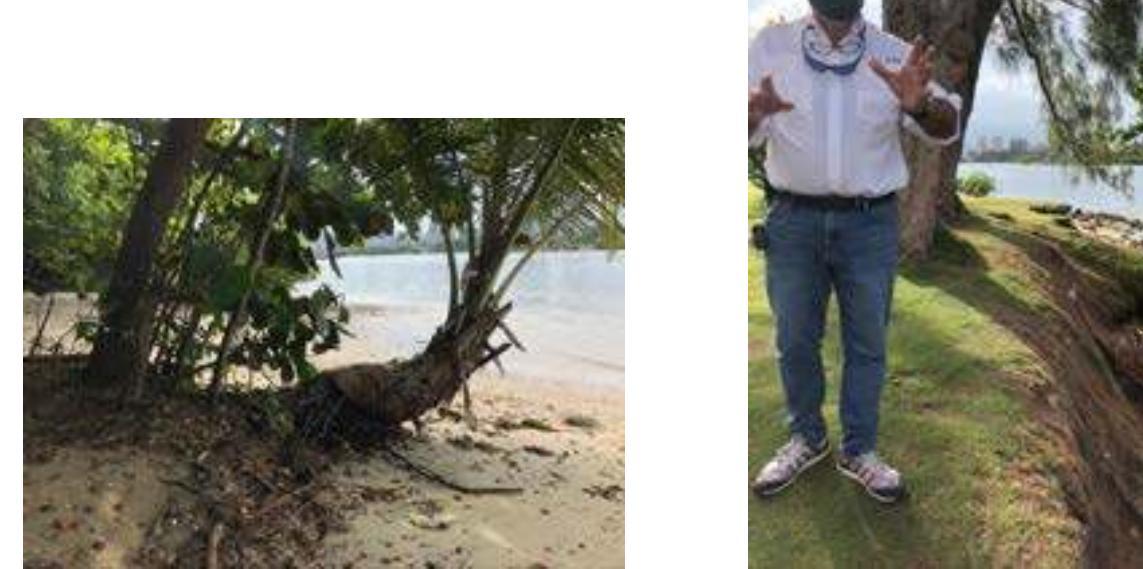
Figure 15. Existing levels of erosion along the north east edge of the Condado Lagoon. (Photos courtesy M. Rodríguez)

In order for planting success across this sector, it is recommended that erosion control measures be put into place at the time of planting.

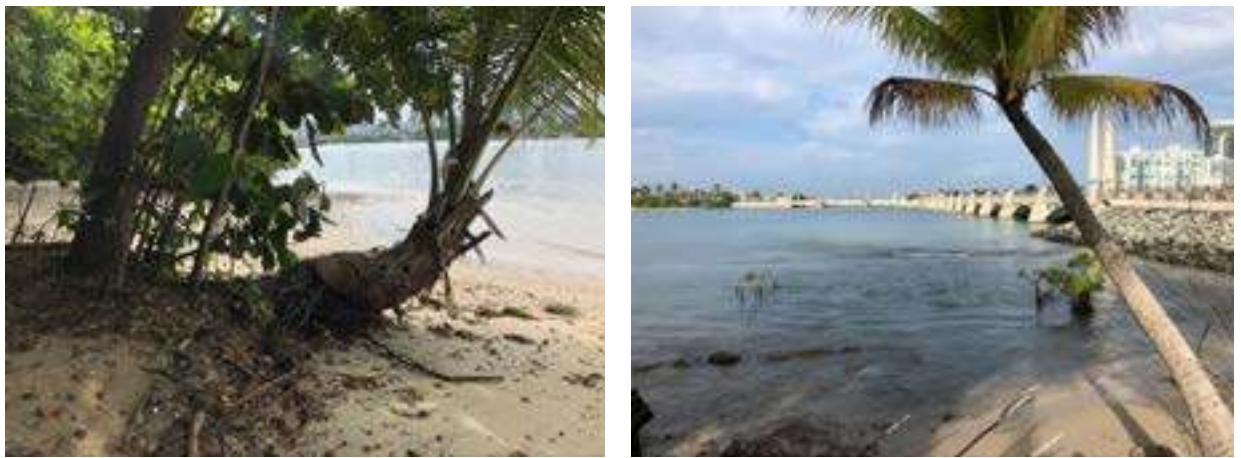
Figure 17. Eroded edges in the Lomita area. (Photos courtesy M. Rodríguez)

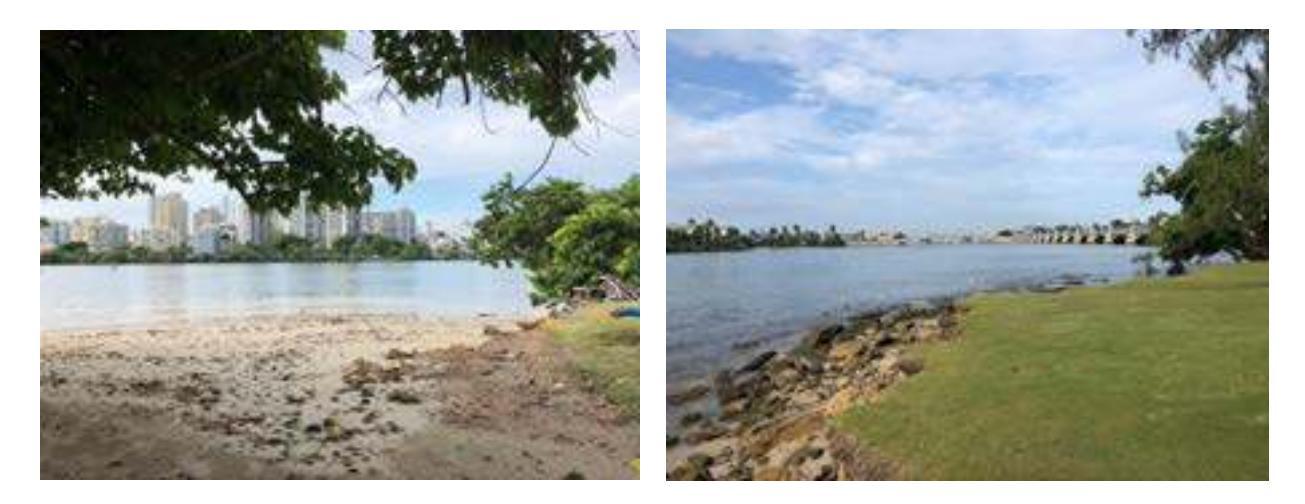
Figure 18. Significantly eroded edges in the Lomita area. (Photos courtesy M. Rodríguez)

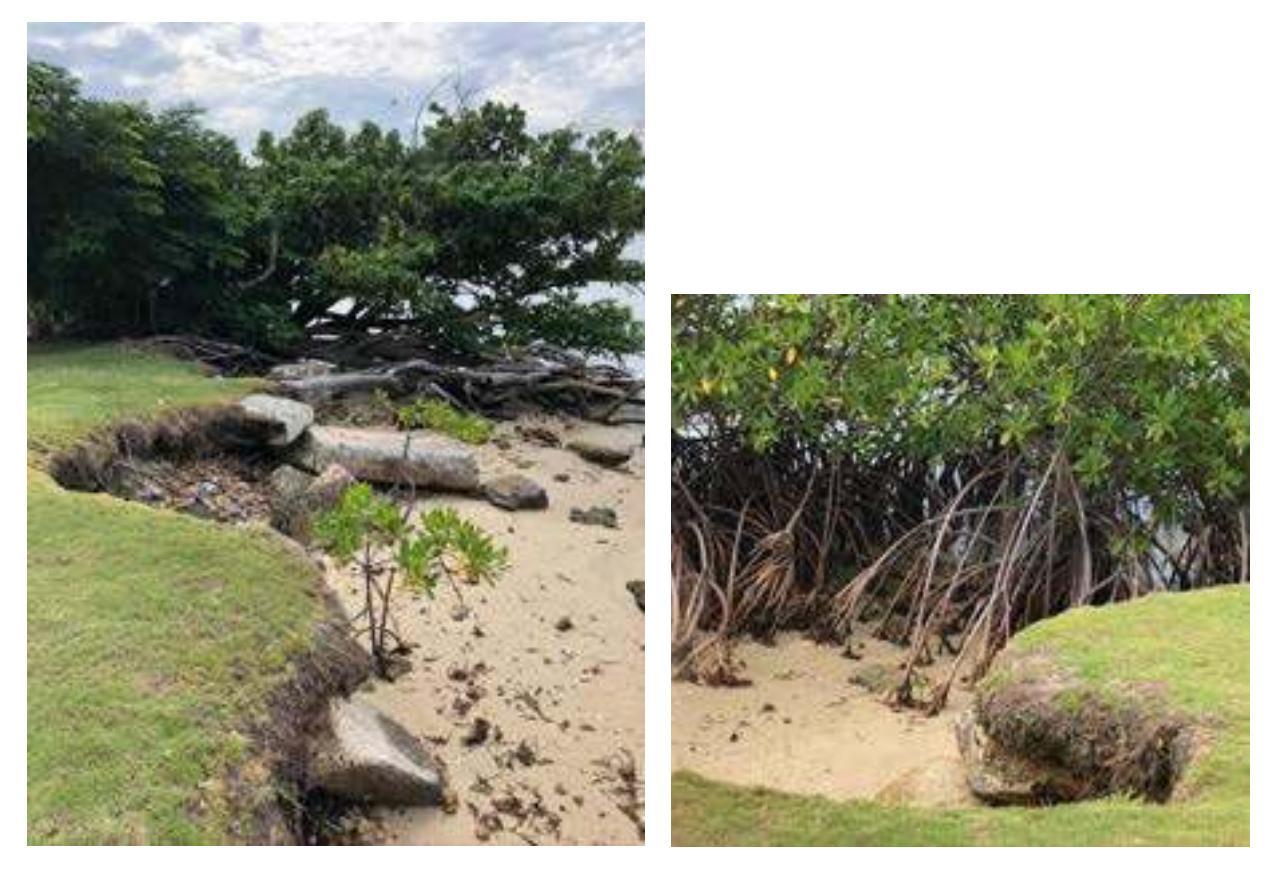
Figure 19. Severely eroded edges in the Lomita area. (Photos courtesy M. Rodríguez)

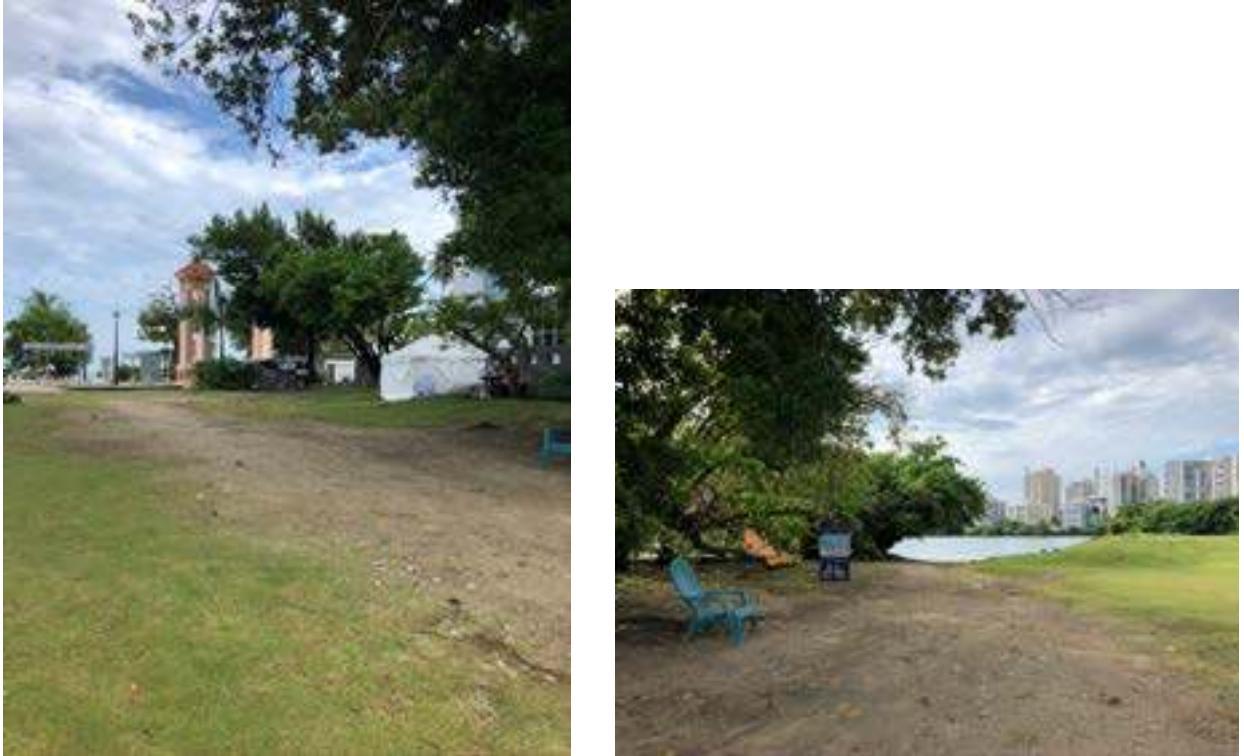
materials, and colors, underscoring a sense of disarray to the area. The soil adjacent to those appurtenances shows compaction and erosion caused by the foot traffic.

Figure 24. Compaction and erosion along main pedestrian path. (Photo courtesy M. Rodríguez)

- It is highly recommended that the Municipality of San Juan set boundaries as to the types of appurtenances that concessions may and may not bring to natural reserves and the types of improvements required of the businesses when their clientele's usage disrupts the property's features.

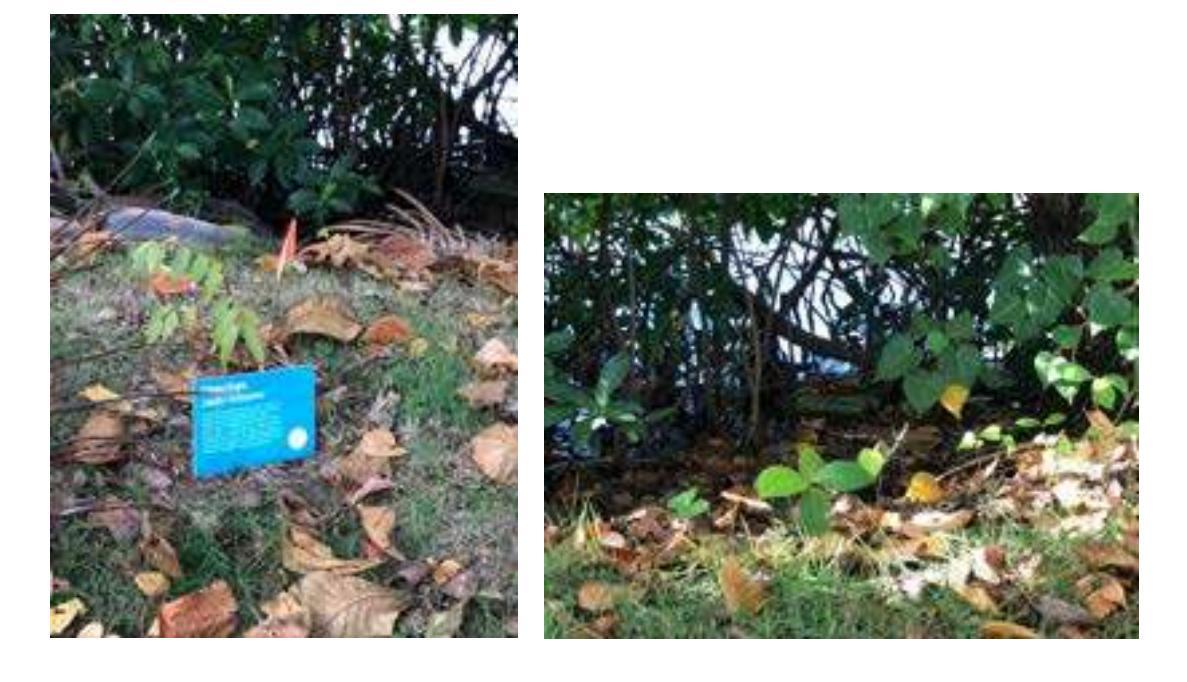
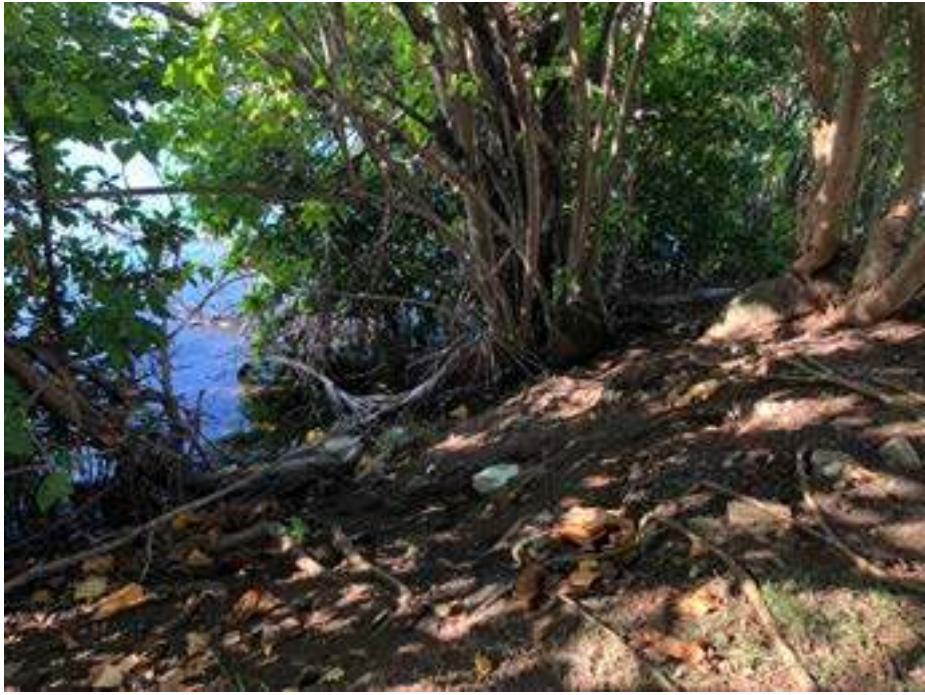
Figure 26. Organic detritus collects around areas of new planting making their visibility difficult. (Photos courtesy M. Rodríguez)

- \circ Potential siting for this could be in close proximity to the existing dumpster.
- Monitoring of planting initiatives
 - Removal of debris from the area surrounding young plantings in the interest of facilitating their visibility, and therefore not to be trampled by area users, and for oxygen and rain to infiltrate as close to the root systems as possible.

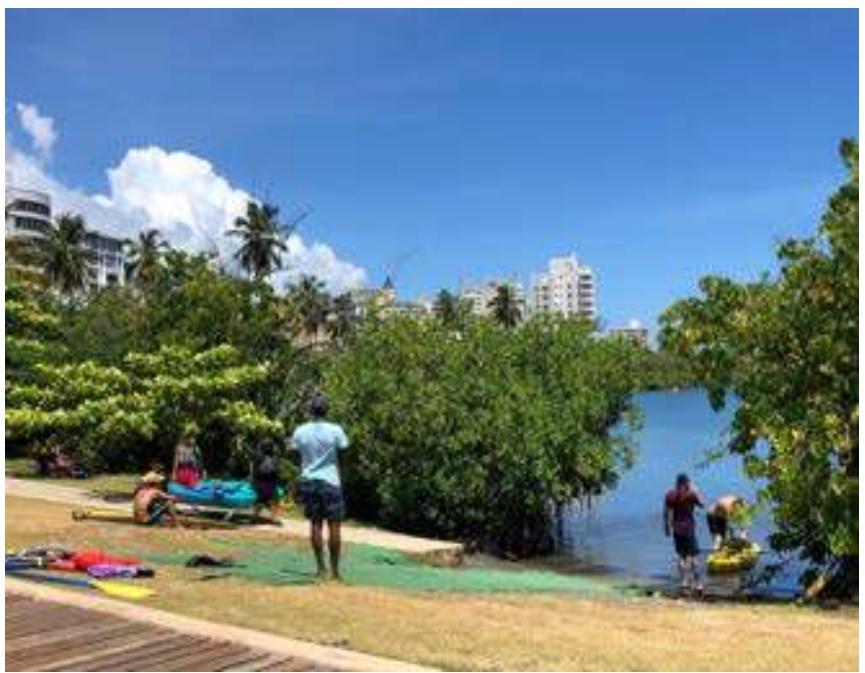
Figure 27. Existing access to the water uses astroturf covering to prevent erosion. (Photos courtesy M. Rodríguez)

- Given the fact that the surrounding soil has been previously impacted by infill material, anchoring points should be pursued inland in this area to avoid disturbing the Lagoon's substrate.

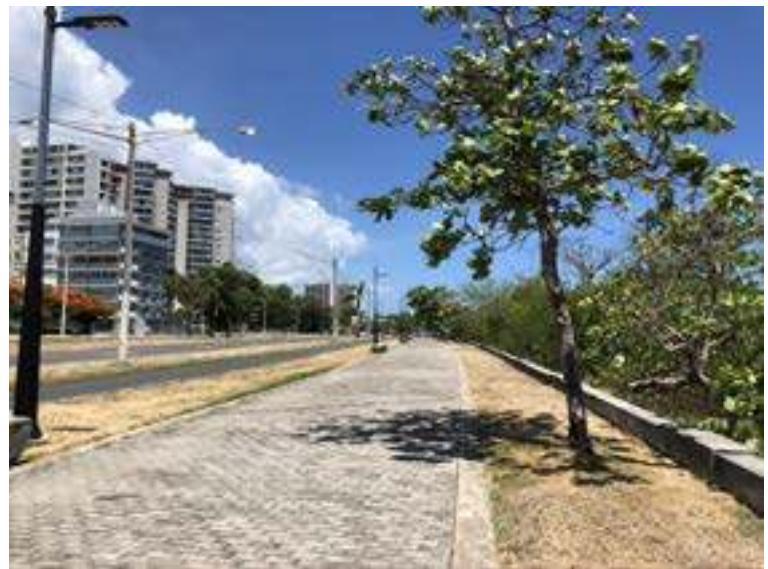
Figure 43. Line of Terminalias missing several specimens to be replanted for shade. (Photo courtesy M. Rodríguez)

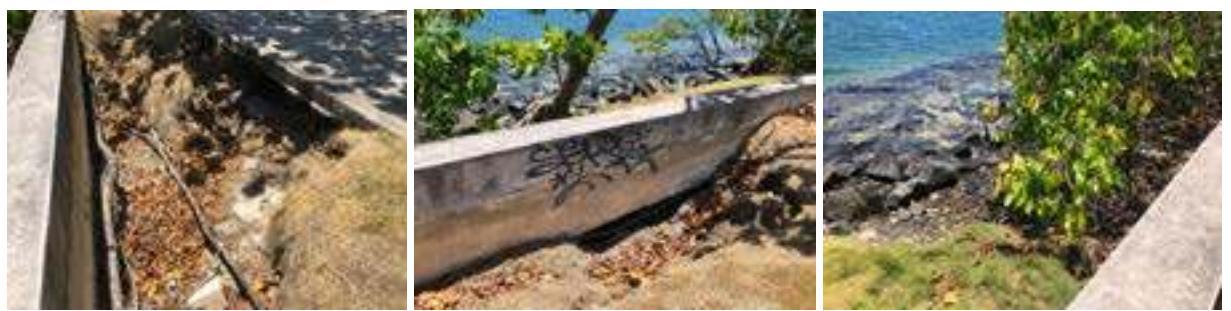
Following several visits to the site and observing the flow of water, it is considered highly probable that storm runoff stemming from streets located on higher ground to the south of the Lagoon, are contributing to the erosion found at critical points in the boardwalk. These highly eroded points appear to coincide with the topographic condition, runoff velocities, and the location of stormwater infrastructure. In several points along Baldorioty Avenue it was also noted that the height between the curb and the infrastructure grill did not exceed 3" as opposed to the regulatory 6", which may be causing water to flow more slowly thus accumulating sediment along these areas.

Figure 44. Eroded points along the boardwalk's retaining wall both inland and in water's edge. (Photos courtesy M. Rodríguez)

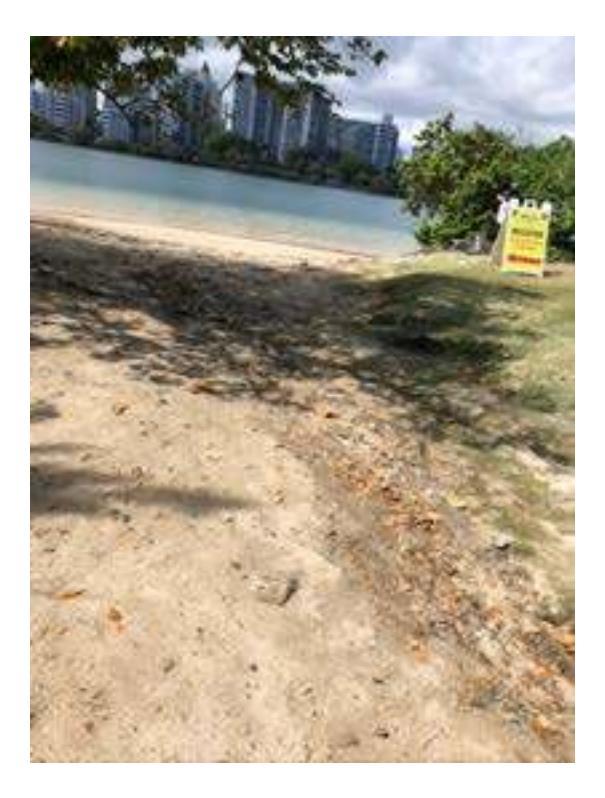
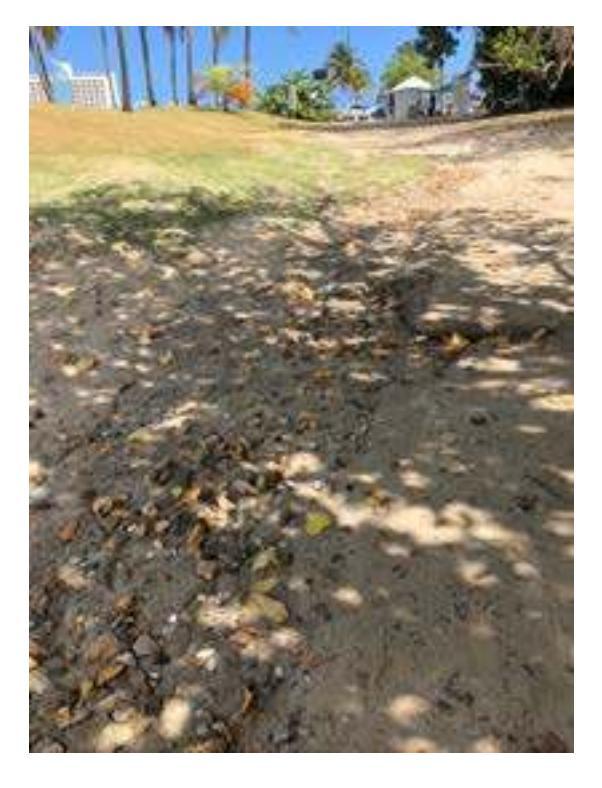
Figure 47. Eroded path caused by pedestrian use and ensuing soil compaction. (Photos courtesy of M. Rodríguez)

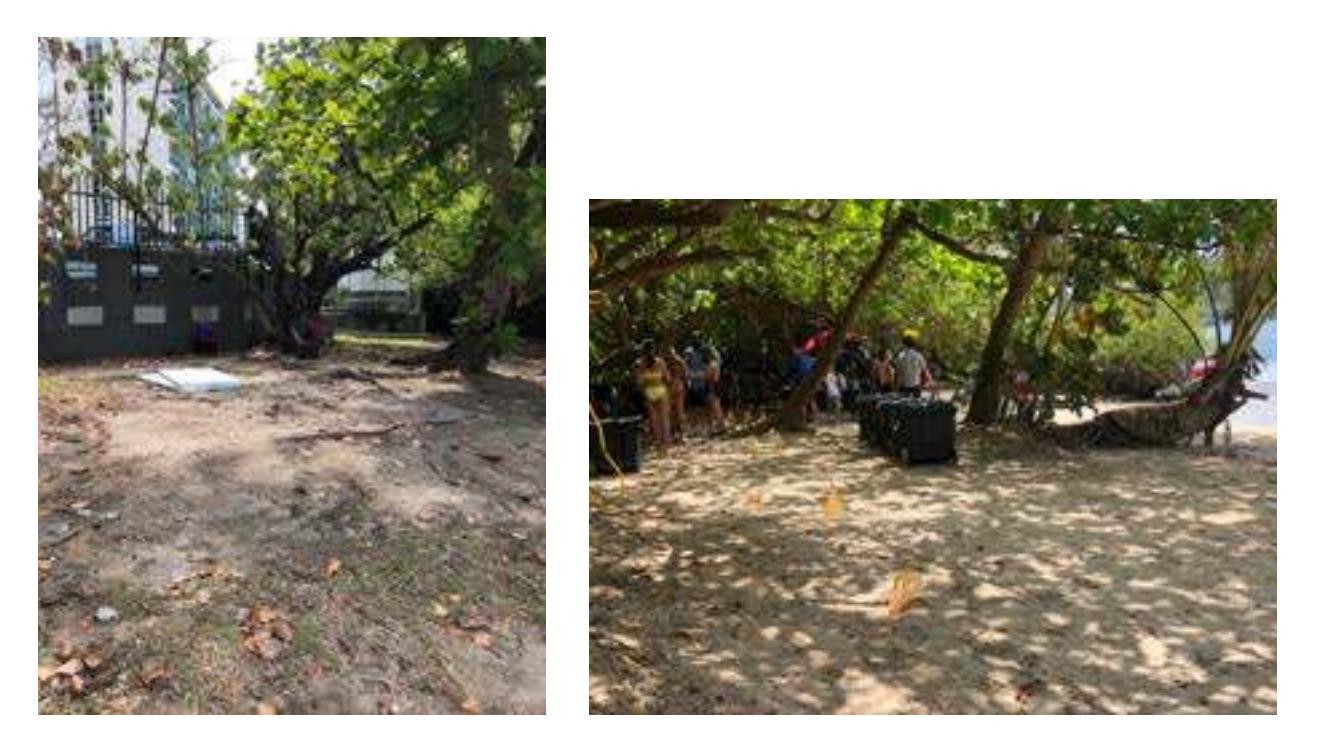
Figure 49. Eroded and compacted soil as result of pedestrian circulation. (Photos courtesy of M. Rodríguez)

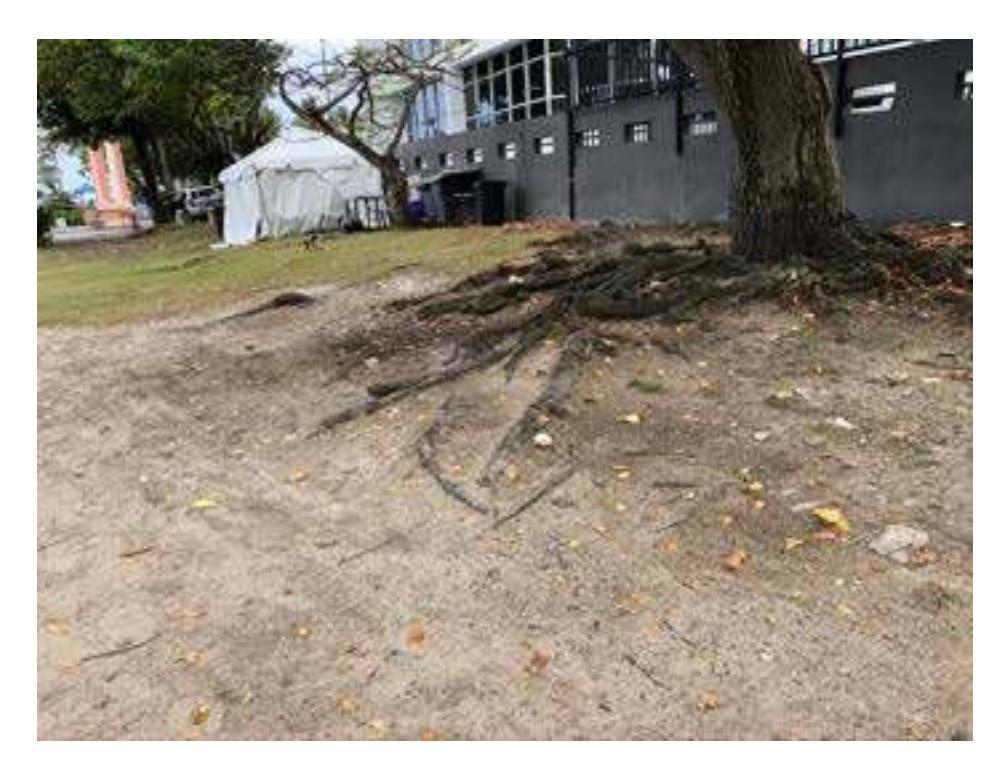
Figure 65. Eroded sector to be planted with Chrysobalanus icaco to prevent further erosion and mitigate sedimentation at the Lagoon and strengthen wildlife habitat, food and pollination. (Photos courtesy of M. Rodríguez)
