GREEN INFRASTRUCTURE PILOT PROJECT - CONDADO LAGOON ESTUARINE RESERVE FINAL REPORT

I. Green Infrastructure Assessment at Condado Lagoon

A. SUMMARY OF EXISTING CONDITIONS, FINDINGS & RECOMMENDATIONS

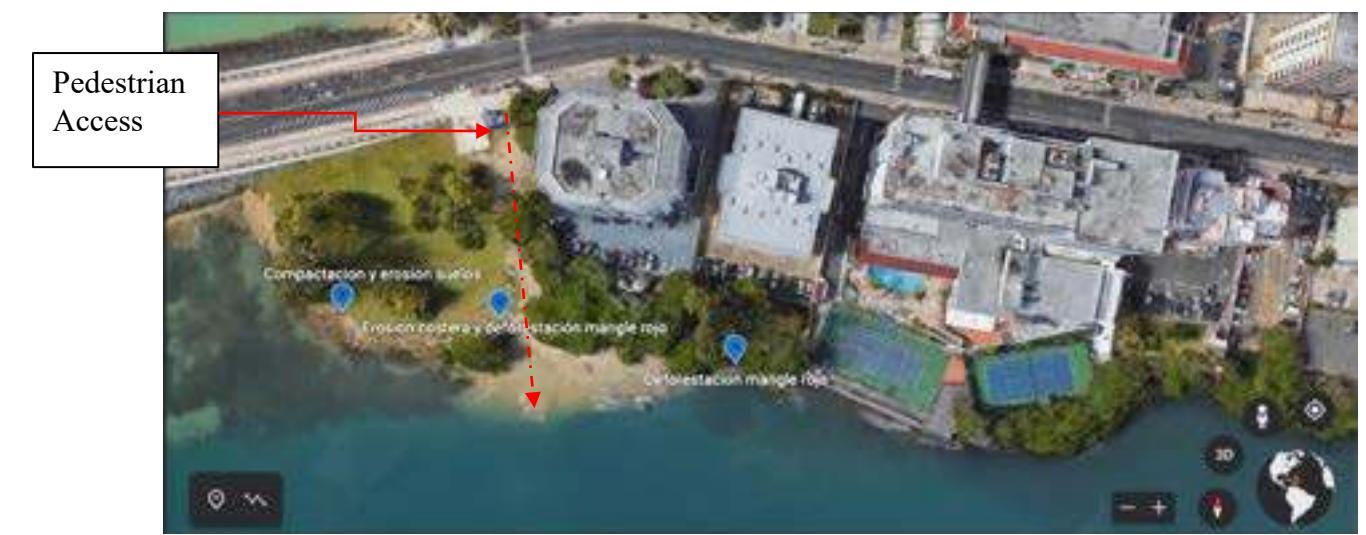
Figure 2. Condado Lagoon north side access. [Google Earth]

Access to the Lagoon and its waters can be attained formally in the north east side from Condado Avenue, and from Baldorioty de Castro on the south side. Access from the north is only viable for pedestrians. At the south east side, vehicular and pedestrian access from Baldorioty de Castro leads into a service road which offers users a way to unload equipment and limited parking opportunities. Access for pedestrians from the west results unsafe. Informal entry points into the boardwalk and water can be observed along the south edge by way of parking on grassed areas and opening up of mangrove "windows" in order to put boards in the water.

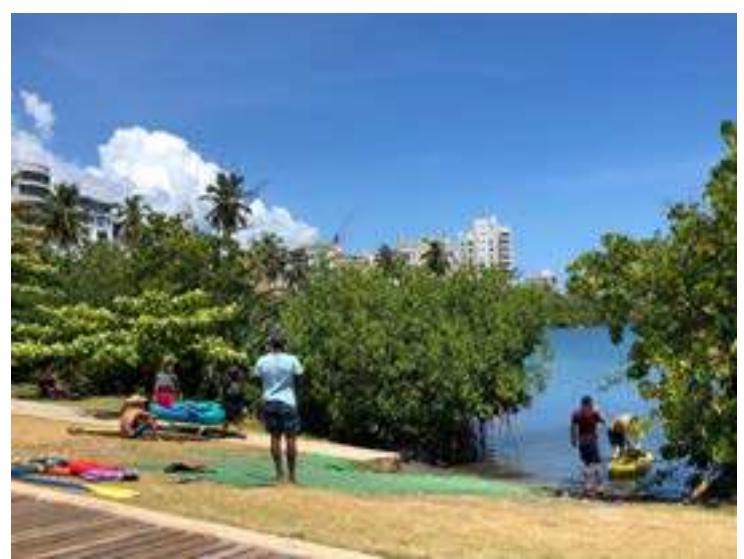
On the south side, the formal entry point to the Lagoon is perhaps the most compacted and eroded. The area concessionary installed an astroturf carpet to diminish the erosion and sedimentation in the water. Both issues will require attention in order to stabilize the water's edge while still retaining the use for area participants.

Figure 11.South side concessionary has installed a temporary astroturf covering in order to cover the eroded soil area at the launching zone. (Photo courtesy of M. Rodriguez)

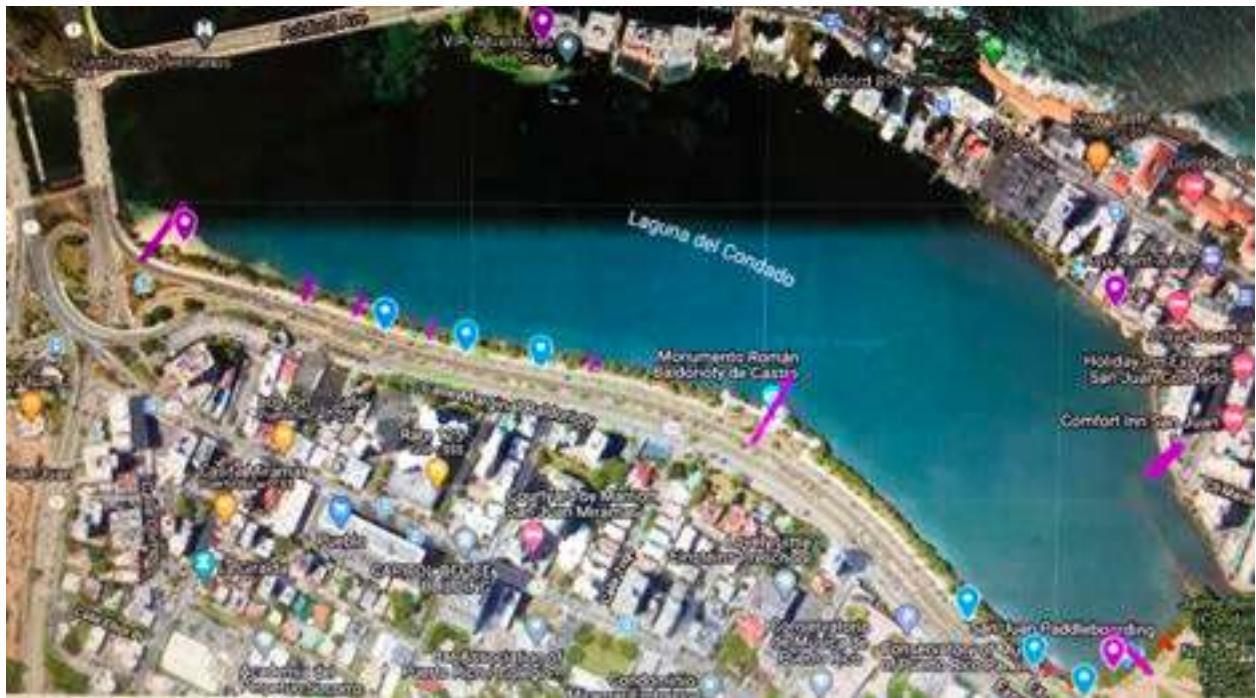
Figure 13. Findings located on map (vistas, erosion, deforestation areas, informal parking areas, access to water). (Photo courtesy of M. Rodríguez)

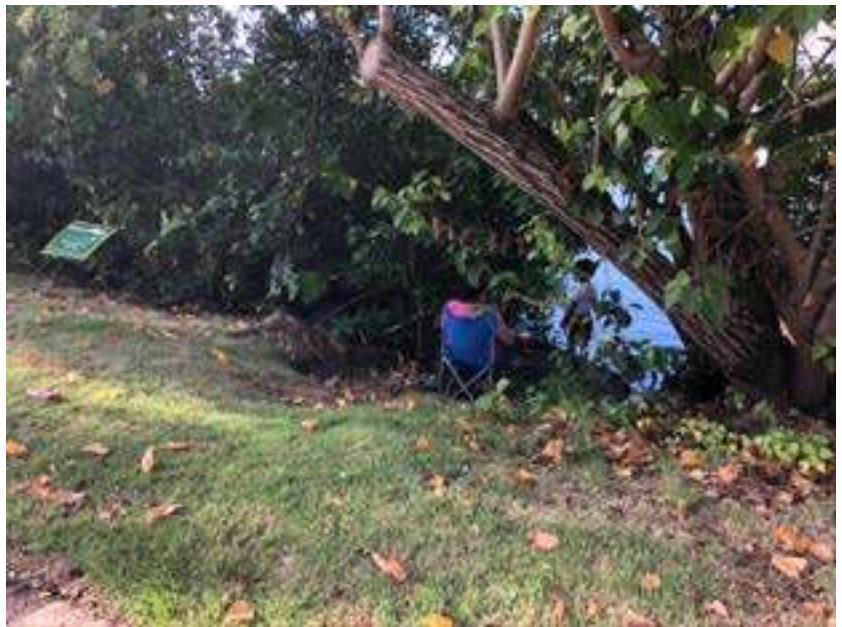
Figure 29. Family enjoying views and people watching at the Lagoon's south side.

- Erosion and soil compaction
 - Create a series of small decks and/or floating docks elevated from the soil to mitigate soil compaction and allowing for passive means of recreation. A Few locations are proposed, guided by persons' use of the space.

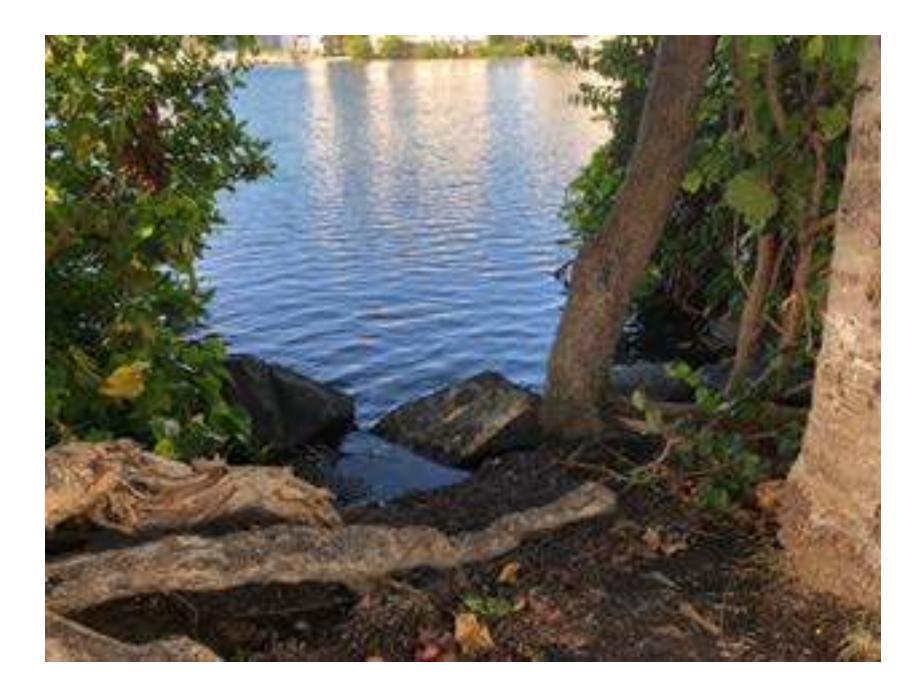
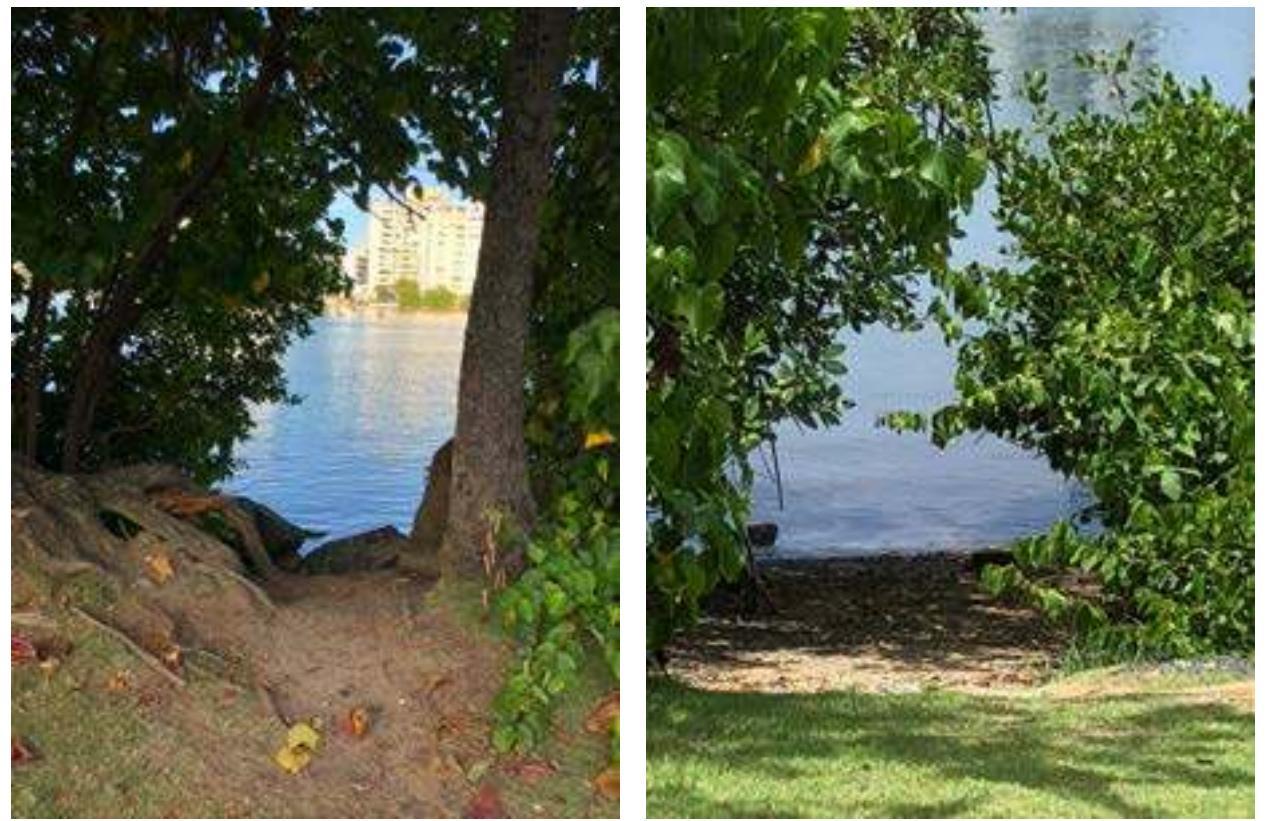
Figure 30. Various points along the vegetated border offer vistas to area users. (Photos courtesy M. Rodríguez)

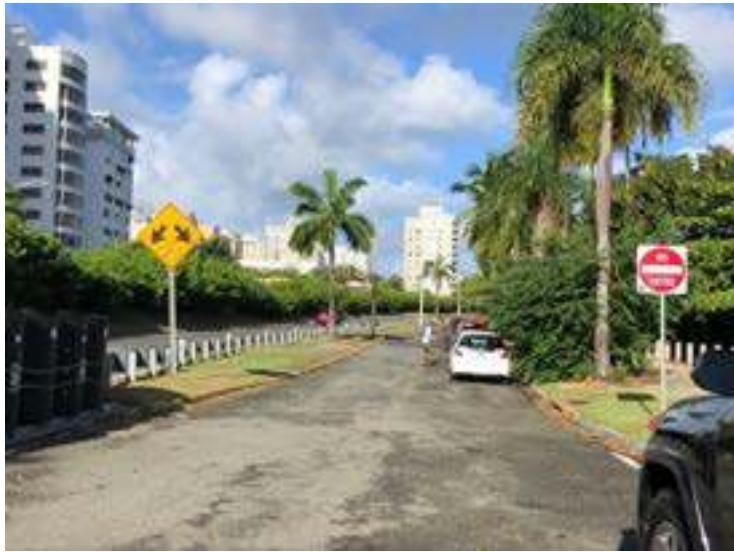
• <u>Erosion management, sedimentation mitigation and runoff infiltration</u> The southeast boardwalk's parking lane and service road (Marginal Baldorioty Avenue) confronts a sedimentation issue resulting from various factors: the stormwater infrastructure's low point, infrastructure in need of maintenance (roots, debris), runoff velocity factor stemming from Baldorioty Avenue at the entrance to the service road. These compounded runoff factors cause the water to back flow into the service road leaving sediments behind as the water slowly percolates the soil.

Figure 31. Existing parking access to park and lagoon amenities. (Photos courtesy M. Rodríguez)

- Sedimentation capture, pollution control, habitat food & nesting, runoff infiltration
 - <u>Bio-swale</u> to capture surface stormwater runoff along the service road which flows in two directions.
 - Installation of <u>speed bumps</u> to redirect the water flow into the bio-swale.
 - <u>Planting strip establishment</u> to redirect stormwater runoff into the existing stormwater management inlets and avoid informal parking in the area (south side)
- Technology
 - <u>Install bio-swales</u> in order to: a) capture partial runoff prior to reaching the storm-water infrastructure, b) infiltrate runoff at these points, c) capture sedimentation, D) conveyance. According to the Environmental School of Forestry at New York State University,

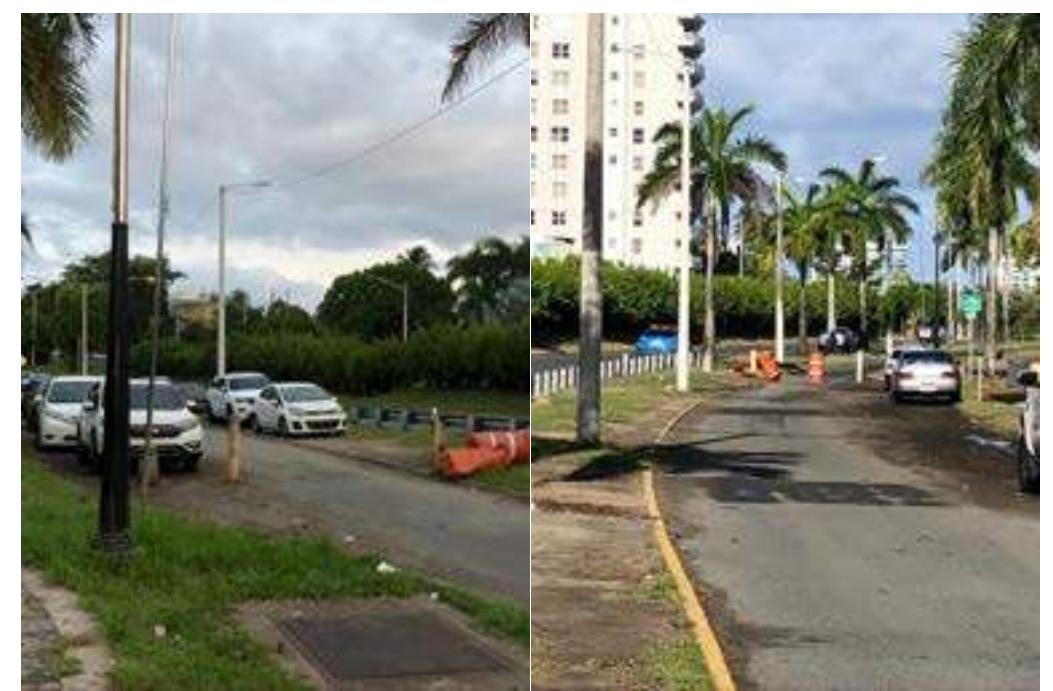
Figure 32. Baldorioty Expressway service road and entrance to Jaime Benitez Park. (Photos courtesy M. Rodríguez)

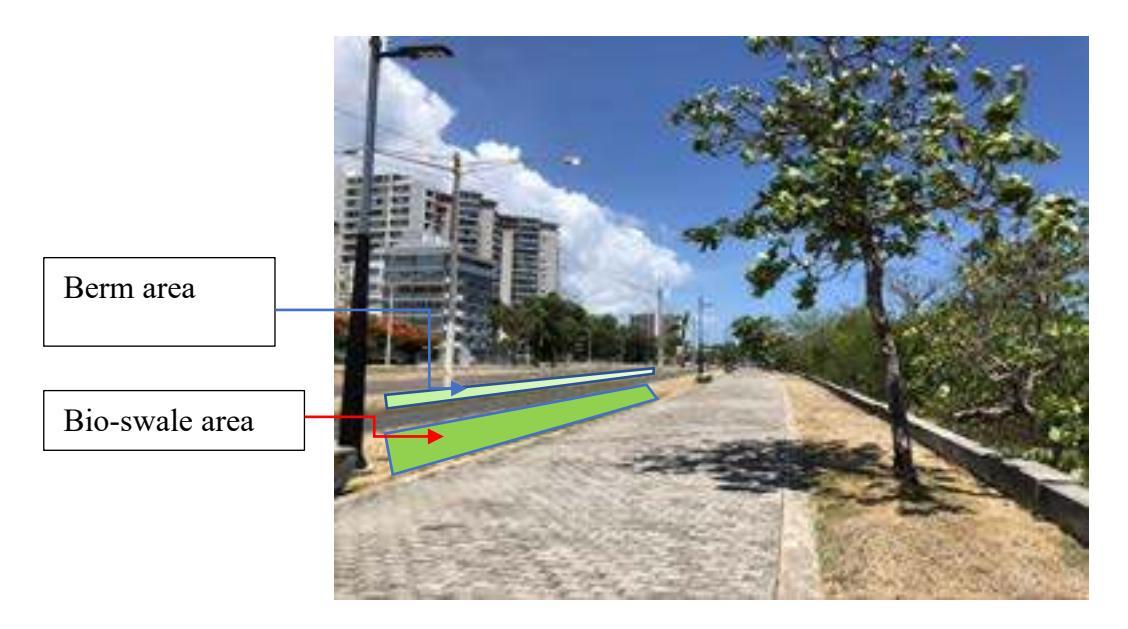
Figure 38. Proposed green infrastructure strategies. (Photos courtesy M. Rodríguez)

- <u>Install raingardens</u> to: a) capture partial runoff and thus relieve pressure from existing storm-water infrastructure, b) infiltrate runoff at these points, c) capture sedimentation, d) conveyance and as complement to the bio-swale strategy.
- Along this stretch, erosion is critical and requires immediate attention, particularly in areas where collapses and minor landslides have occurred. The use of simultaneous strategies and types of best management practices is recommended in this segment to address the varying issues occurring at the site.

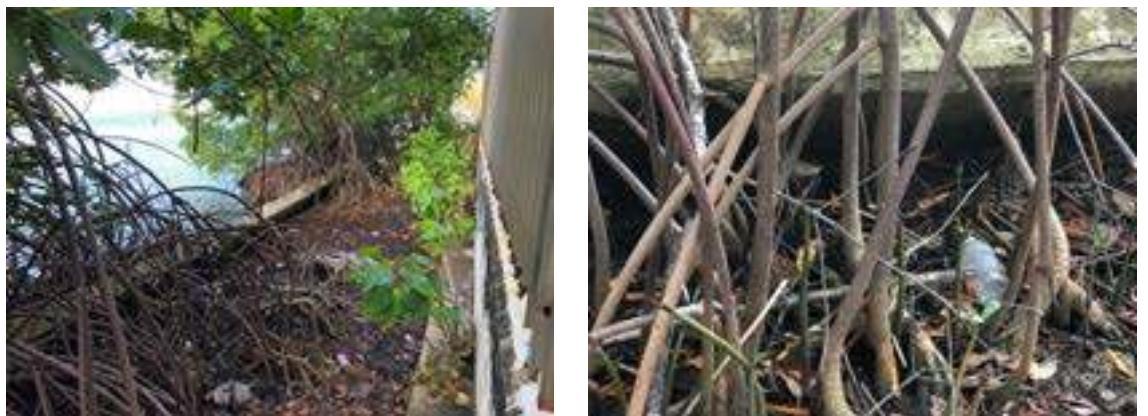
Three zones of 8 stakes with 4 propagules each are proposed at each of the sectors which are missing vegetation currently. Some propagules at the site are establishing themselves under the shade of more mature red mangroves suggesting that their root system is receiving sufficient water through capillary action when the tide is low. Planting additional "seedlings" is proposed to reinforce the existing red mangrove growth in this segment and to continue expanding, where possible, to the northwest.

Figure 45. Embankment area along Le Rivage building with patches of red mangrove; propagules spontaneously getting established in area. (Courtesy of M. Rodríguez)

As part of the consolidation phases of the red mangrove forest along the south east border of the Lagoon, expansion towards the northeast side is proposed, abutting Le Rivage building. A fragmented segment of established red mangrove forest exists at the end of Joffre Street which can be connected with a planting activity.

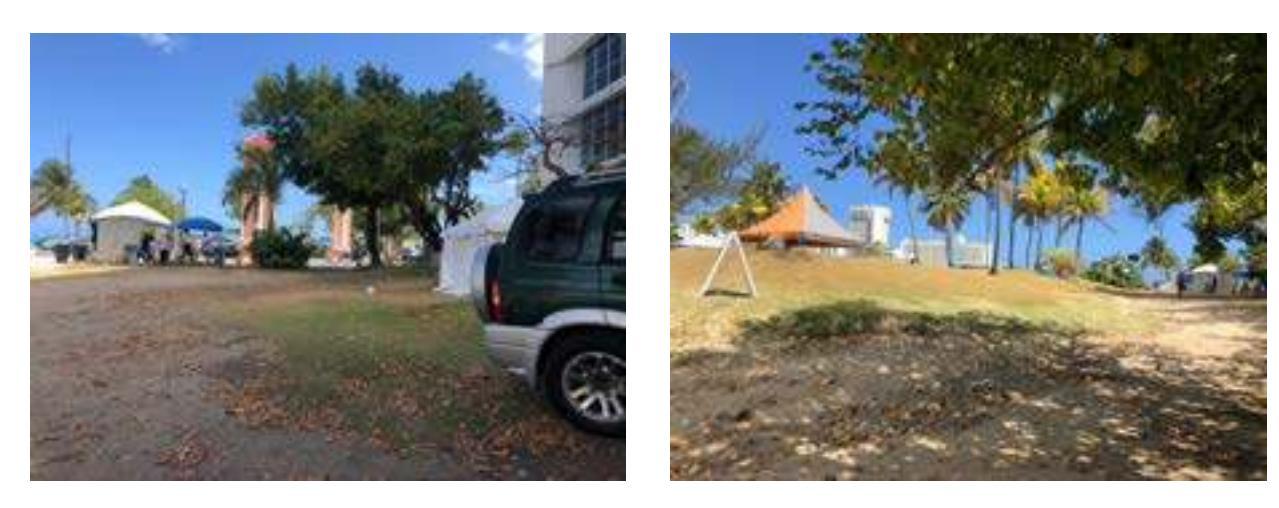
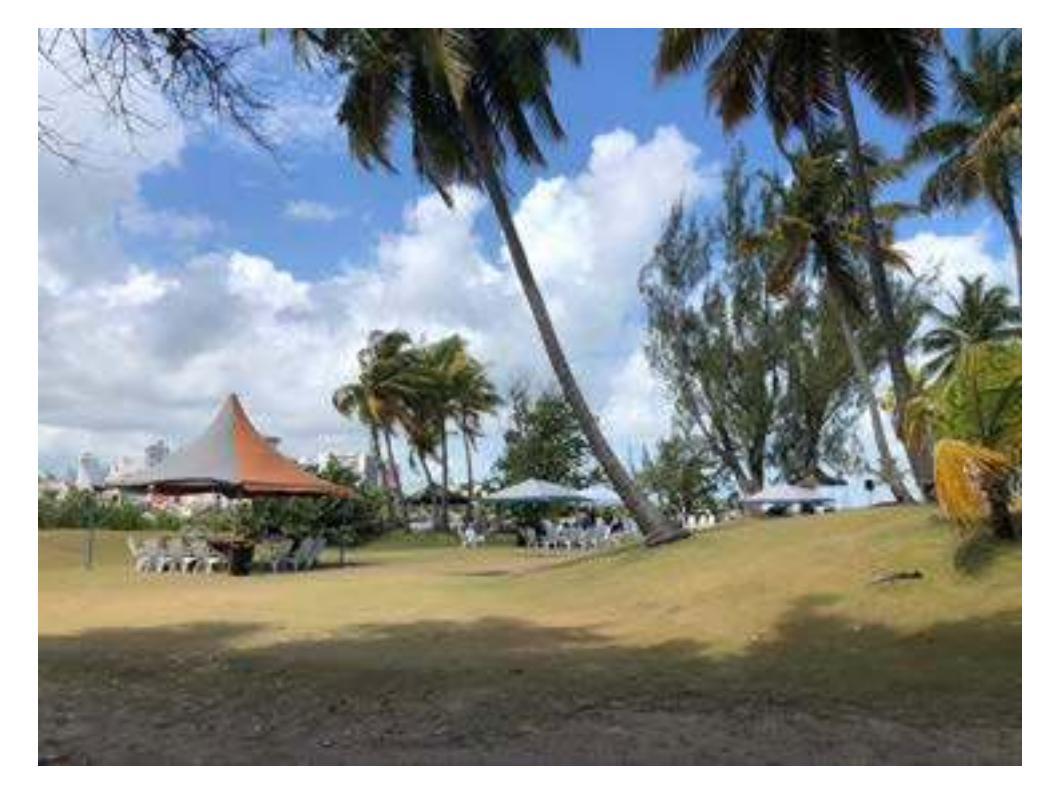
Figure 46. Various existing uses at the Condado Lagoon's north entrance. (Photos courtesy of M. Rodríguez)

As mentioned earlier, the number of persons using this entrance and the increased level of pedestrian traffic have caused the grass and some understory shrubs to "die-out", the soil to become compacted, which in turn has created eroded areas where the foot traffic occurs. The area impacted by individuals has increased as evidenced by the dead grass or understory shrubs being used to hang signage or to shelter other concession stand belongings. Therefore, eroded particulate stemming from these zones is likely to reach the Lagoon's waters during heavy rainfalls and causing sedimentation.

It is recommended that formal pathways be defined to avoid further soil compaction and erosion. Given the site's attributes, sectionally sliced fallen palm tree trunks can be installed as pathways or, more long term, a wooden walkway could be considered. The porosity of the palm tree trunks provides a safe non-slip surface. Although a wooden walkway would constitute the most cost-effective alternative in the long-run, due to local maintenance budgetary concerns, the recommendation would be to pursue the fallen palm tree trunks option. This same treatment is proposed for installation in sectors where concession stands are additionally compacting and eroding the soil.

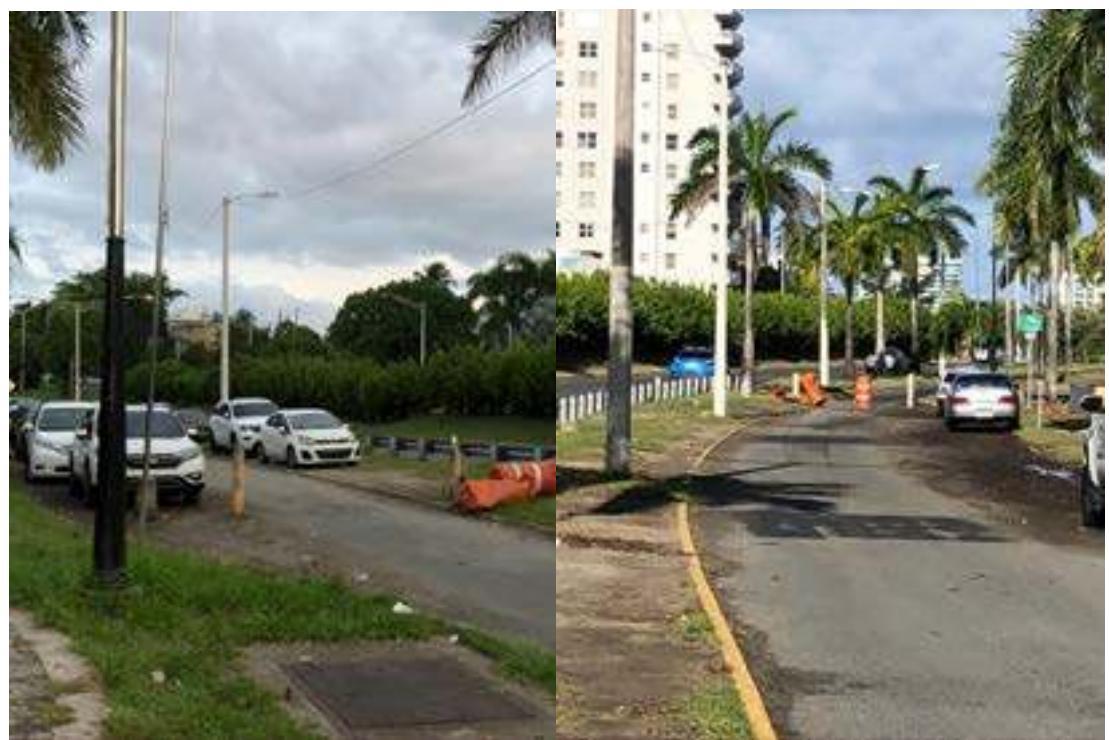
The southeast Jaime Benítez Park entrance and service road (Marginal Baldorioty Avenue) confronts a sedimentation issue resulting from various factors: the stormwater infrastructure's low point, infrastructure in need of maintenance (roots), runoff velocity factor stemming from Baldorioty Avenue at the entrance to the service road. These compounded runoff factors cause the water to back flow into the service road leaving sediments behind as the water slowly percolates the soil.

Figure 53. Baldorioty Expressway service road and entrance to Jaime Benítez Park. (Photos courtesy M. Rodríguez)

A multi-tiered approach is proposed to control sedimentation, water pollution control, and runoff infiltration by using a bio-swale at the existing planting strip, formal plantings at the planting strip and install speed bumps to redirect the water flow into the bioswale. The bio-swale intends to: a) capture partial runoff prior to reaching the stormwater infrastructure, b) infiltrate runoff at these points, c) capture sedimentation, d) provide conveyance. The planting strip establishment seeks to redirect stormwater runoff into the existing stormwater management inlets and avoid informal parking in the area (south side).

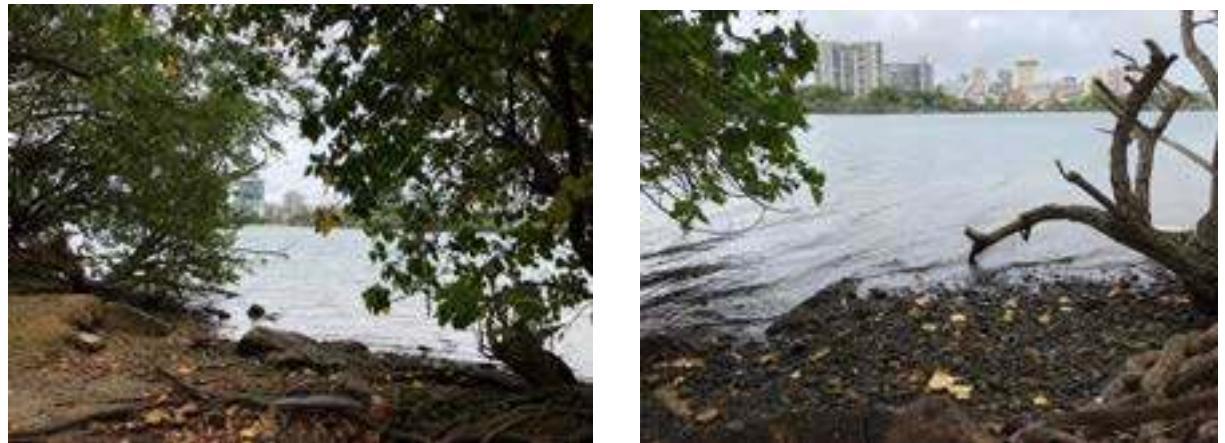
Figure 64. Red mangrove area patches to be consolidated. (Photos courtesy of M. Rodríguez)

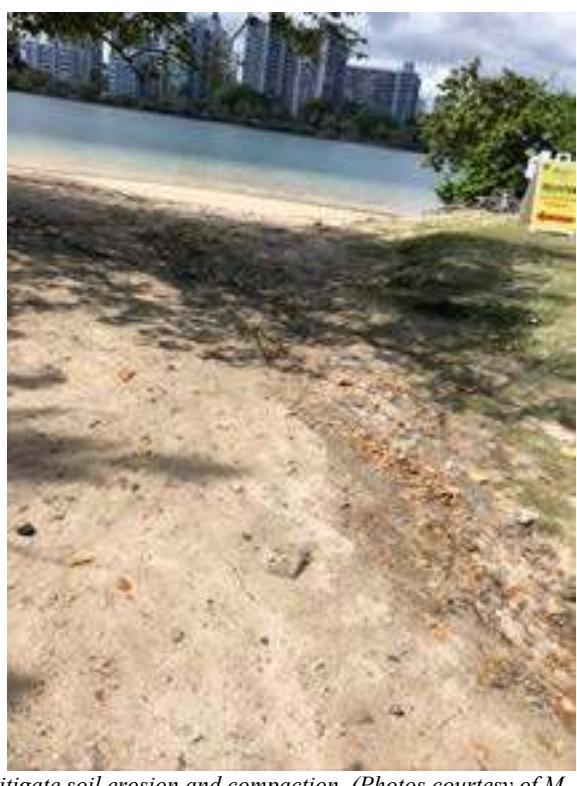
Figure 66. Areas to define the limit of pedestrian circulation to mitigate soil erosion and compaction. (Photos courtesy of M. Rodríguez)
